DEPARTMENT OF TRANSPORTATION

Quality Assurance and Source Inspection

Contract #: 04-0120F4Cty: SF/ALA Rte: 80 PM: 13.2/13.9File #: 69.28**WELDING INSPECTION REPORT****Resident Engineer:**Pursell, Gary**Address:** 333 Burma Road**City:** Oakland, CA 94607**Report No:** WIR-003280**Date Inspected:** 07-Jul-2008**Project Name:** SAS Superstructure**OSM Arrival Time:** 1400**Prime Contractor:** American Bridge/Fluor Enterprises, a JV**OSM Departure Time:** 2330**Contractor:** Zhenhua Port Machinery Company, Ltd (ZPMC), Changxing Island **Location:** Shanghai, China**CWI Name:** Li Yanhua**CWI Present:** Yes No**Inspected CWI report:** Yes No N/A**Rod Oven in Use:** Yes No N/A**Electrode to specification:** Yes No N/A**Weld Procedures Followed:** Yes No N/A**Qualified Welders:** Yes No N/A**Verified Joint Fit-up:** Yes No N/A**Approved Drawings:** Yes No N/A**Approved WPS:** Yes No N/A**Delayed / Cancelled:** Yes No N/A**Bridge No:** 34-0006**Component:** OBG**Summary of Items Observed:**

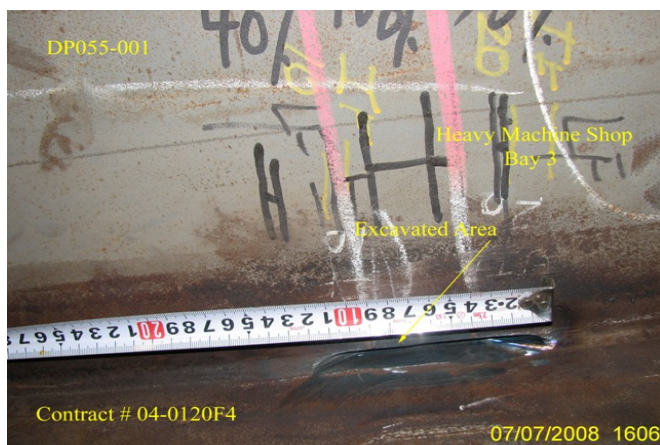
The QA inspector observed ZPMC in the process of preheating an area which had been excavated to repair an area which ZPMC had performed ultrasonic testing (UT) and found an indication which required repair. The reject report for lack of penetration (LOP) was listed by ZPMC as B787 UT-720 and the repair reports were listed as BWR496 and BWR497.

The weld repairs were to be performed at two locations on the deck panel DP055-001 U-Ribs, one on weld number 6 and one on weld number 10.
